Deer Creek Erosion Control Project

FINAL REPORT

California State University, Chico Research Foundation

August, 2001

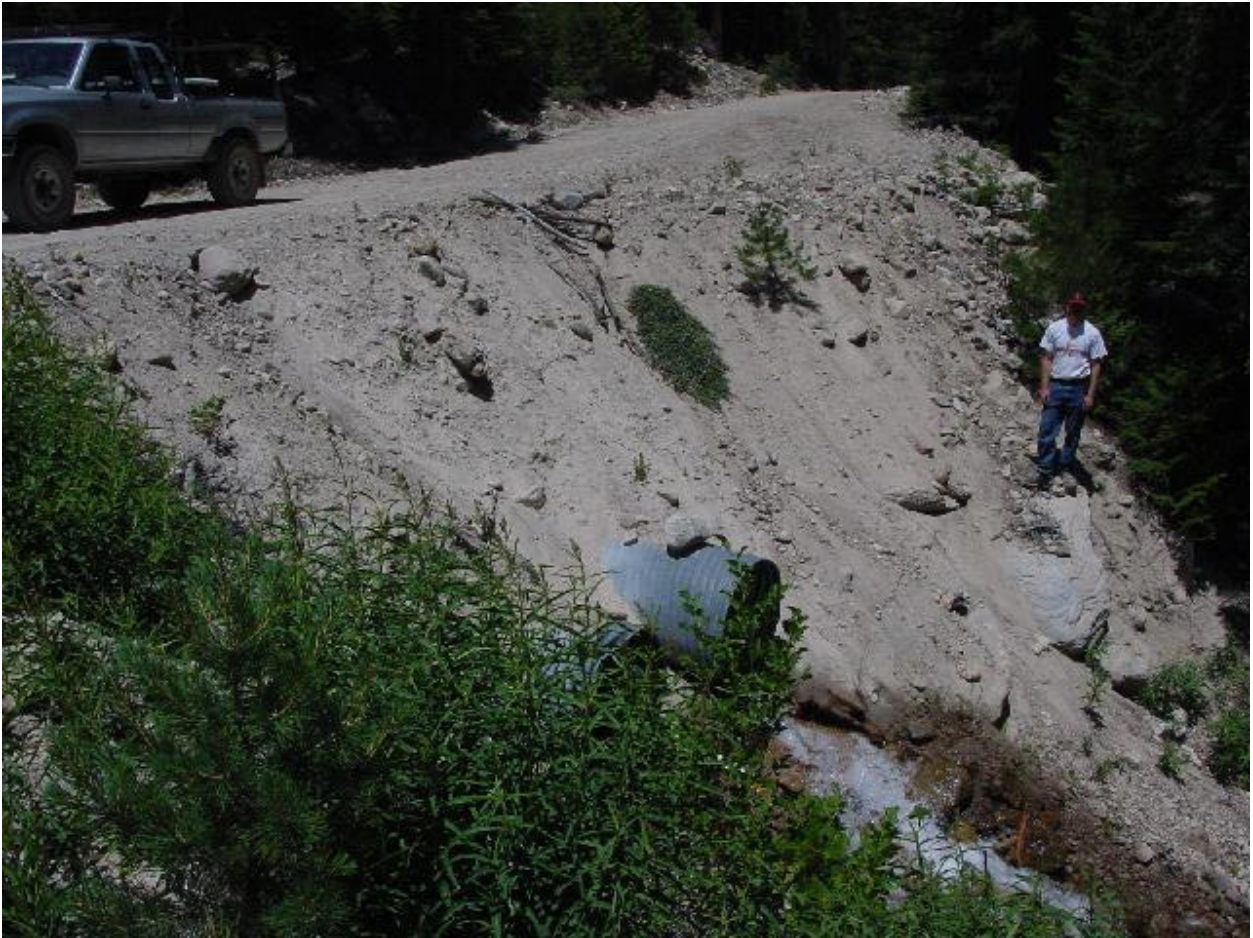
Photo 4.23a

Site 4.23—Above

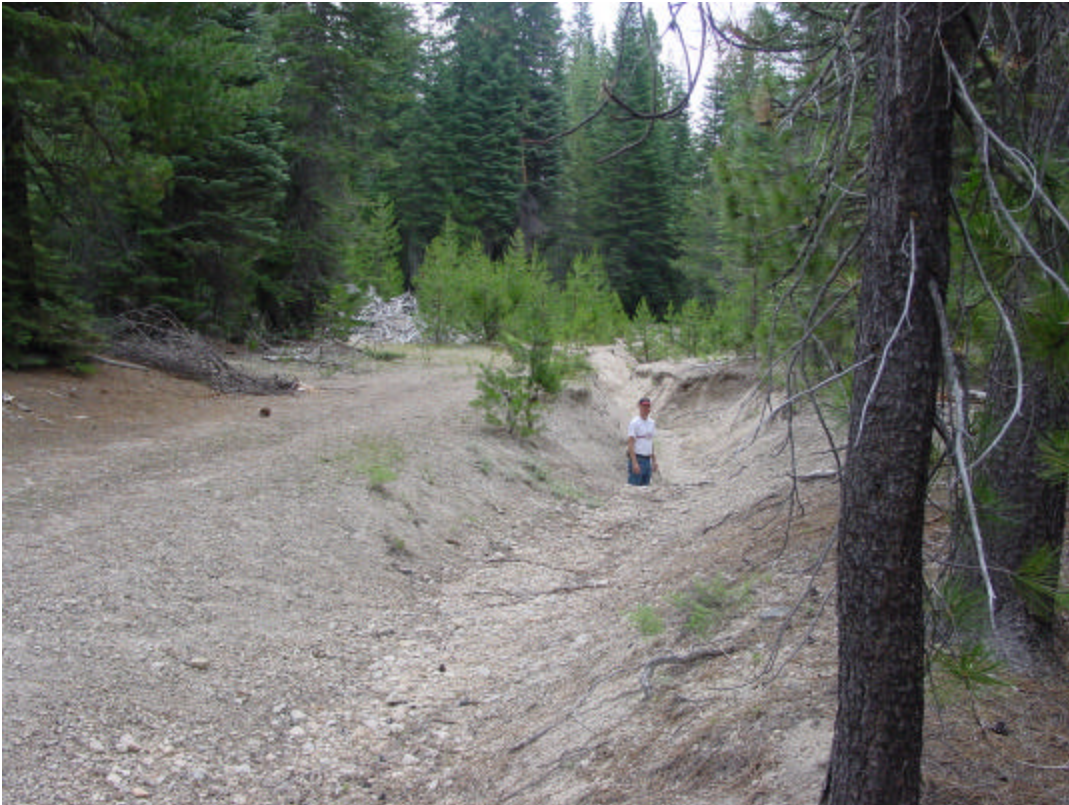
Photo 5.b

Photo 5.b—Prior to start of head cut.

Site 5: Road 1545-1—Prior to start of head cut.

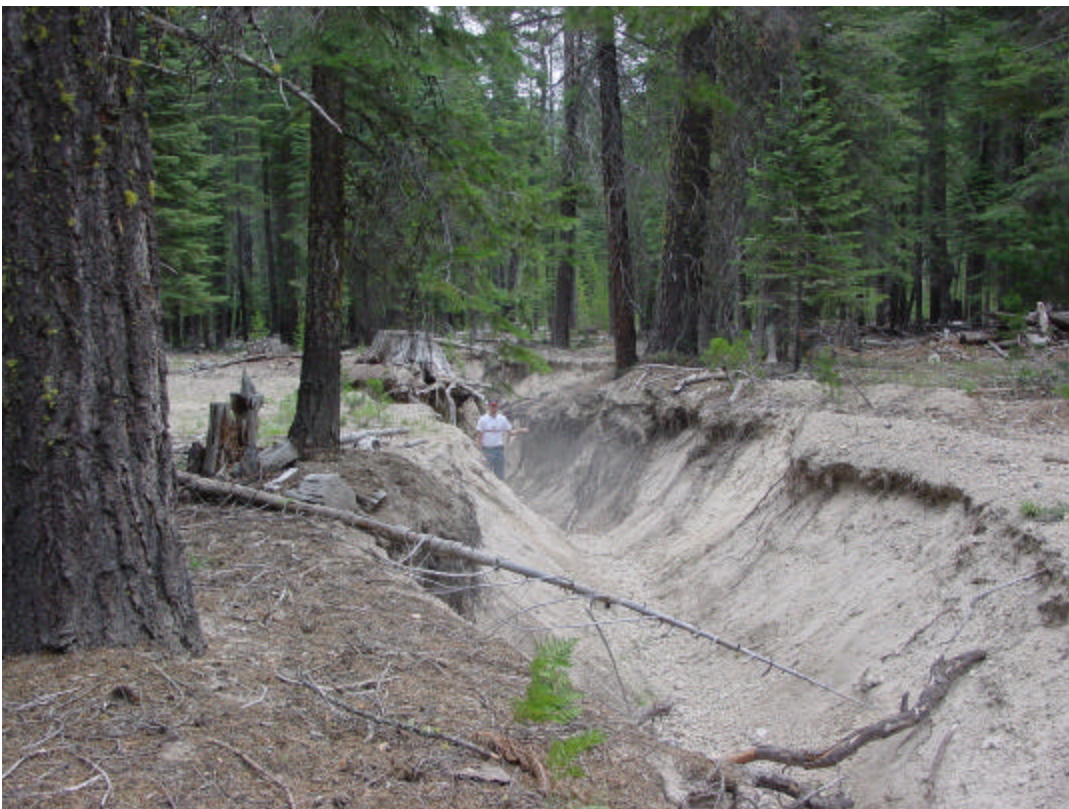
Photo 5.c

Photo 5.c—Beginning of head cut.

Site 5: Road 1545-1—Beginning of head-cut.

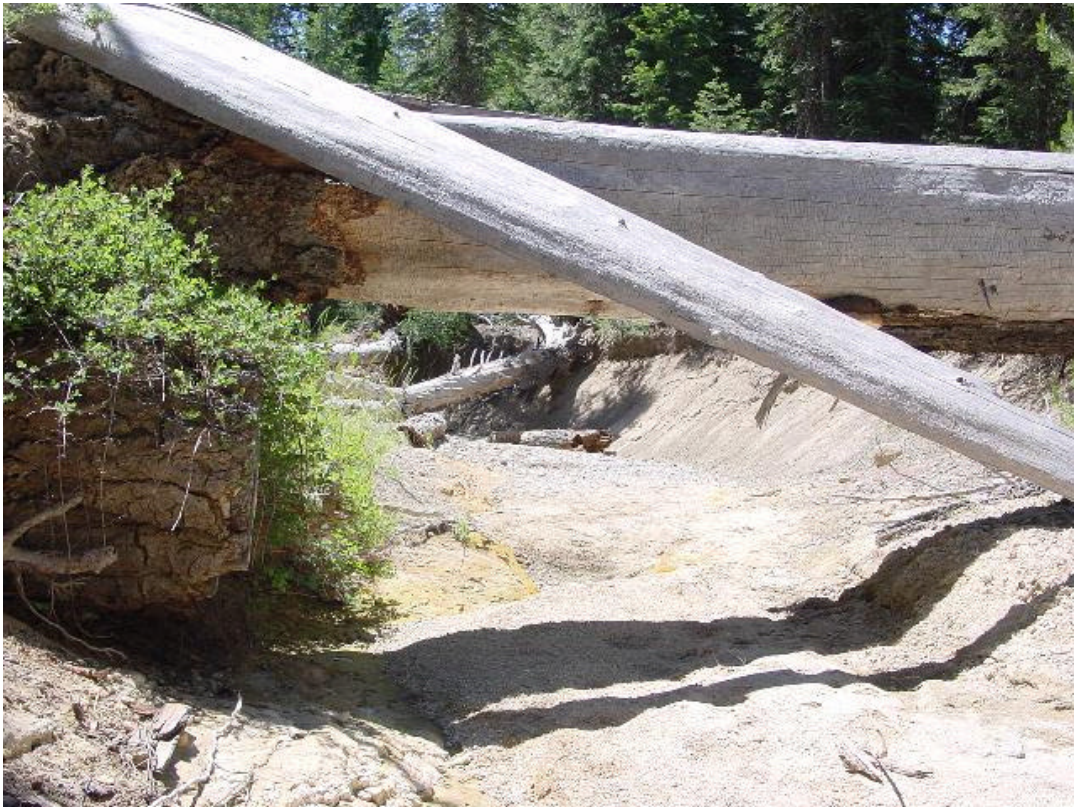
Photo 10.a

1422 Spur road—Woody Material above treatment area

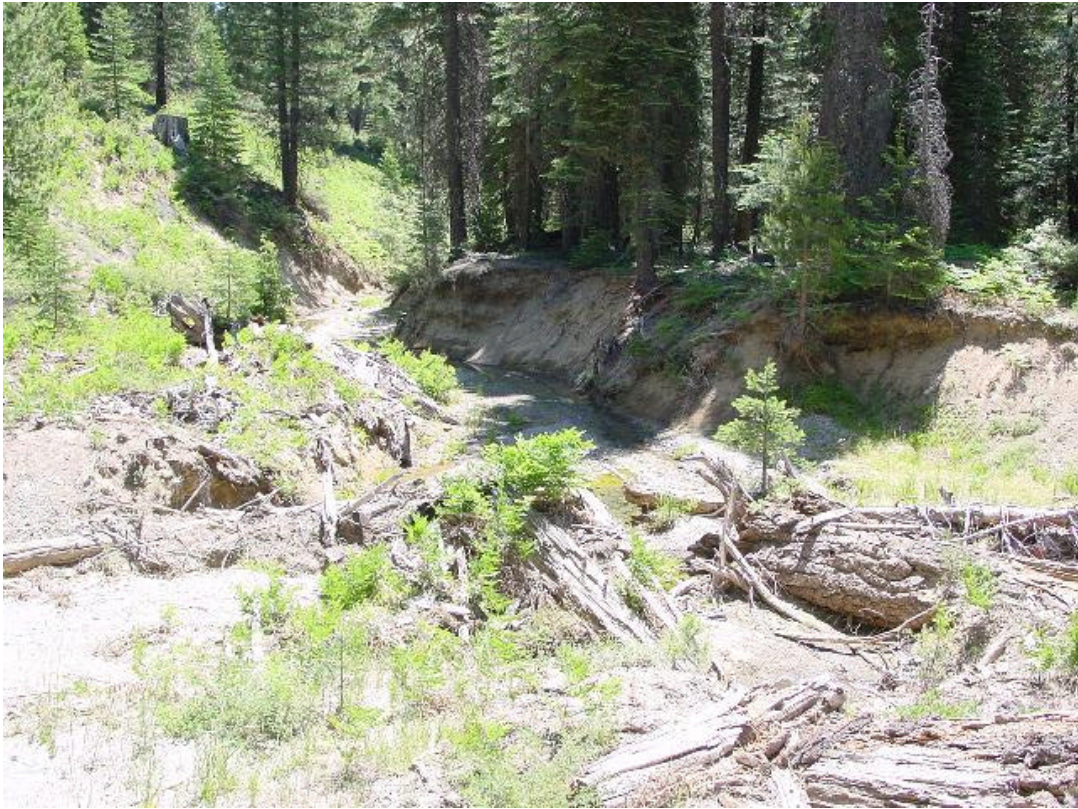
Photo 10.b

1422 Spur road—Looking downstream, upper end

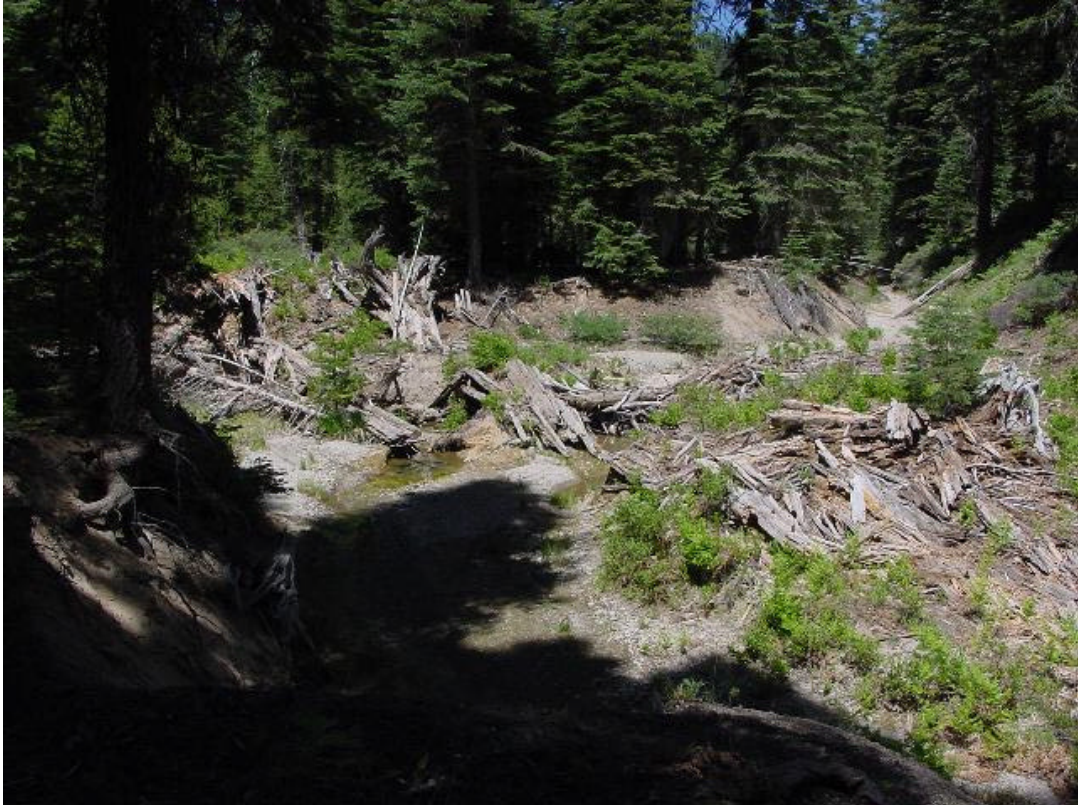
Photo 10.c

1422 Spur road—Looking upstream, upper end

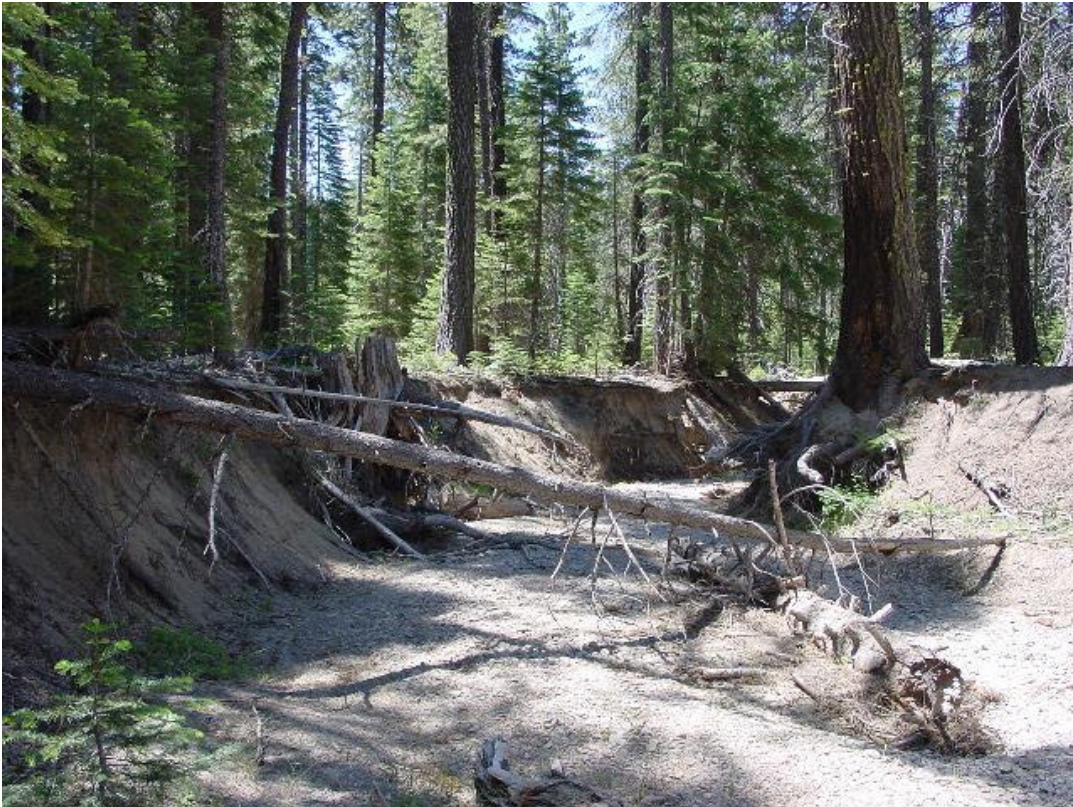
Photo 10.d

1422 Spur road—Ineffective natural woody material

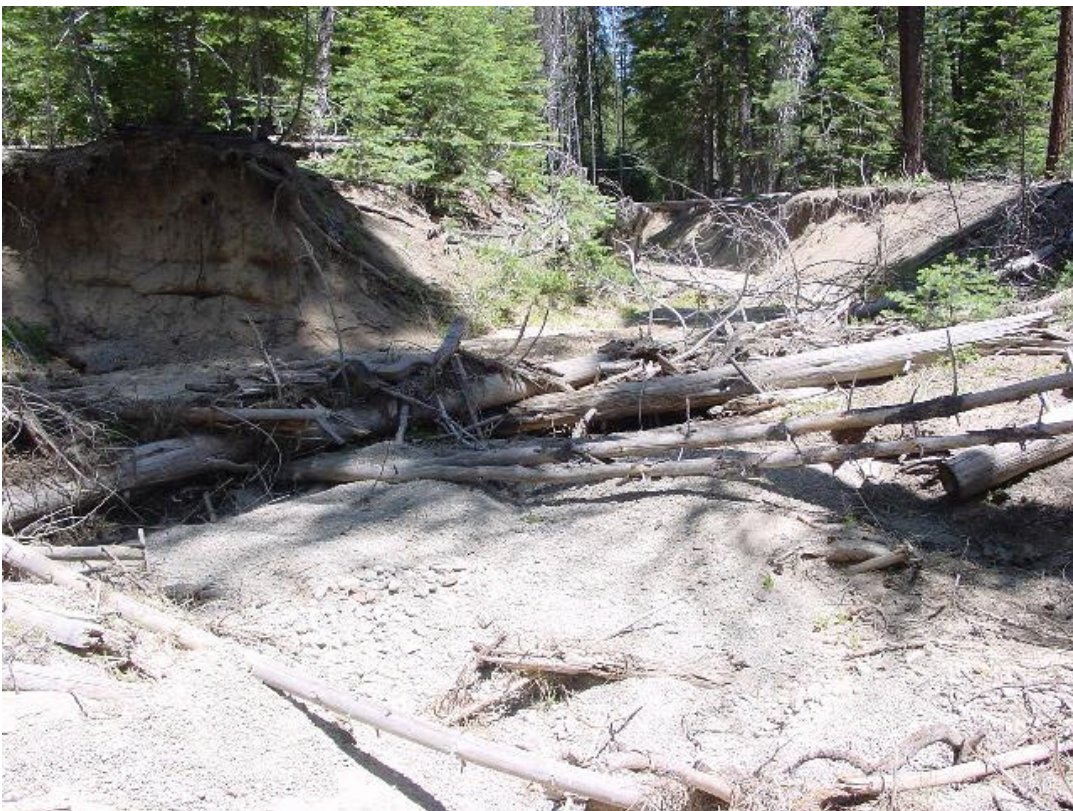
Photo 10.e

1422 Spur road—effective natural woody material

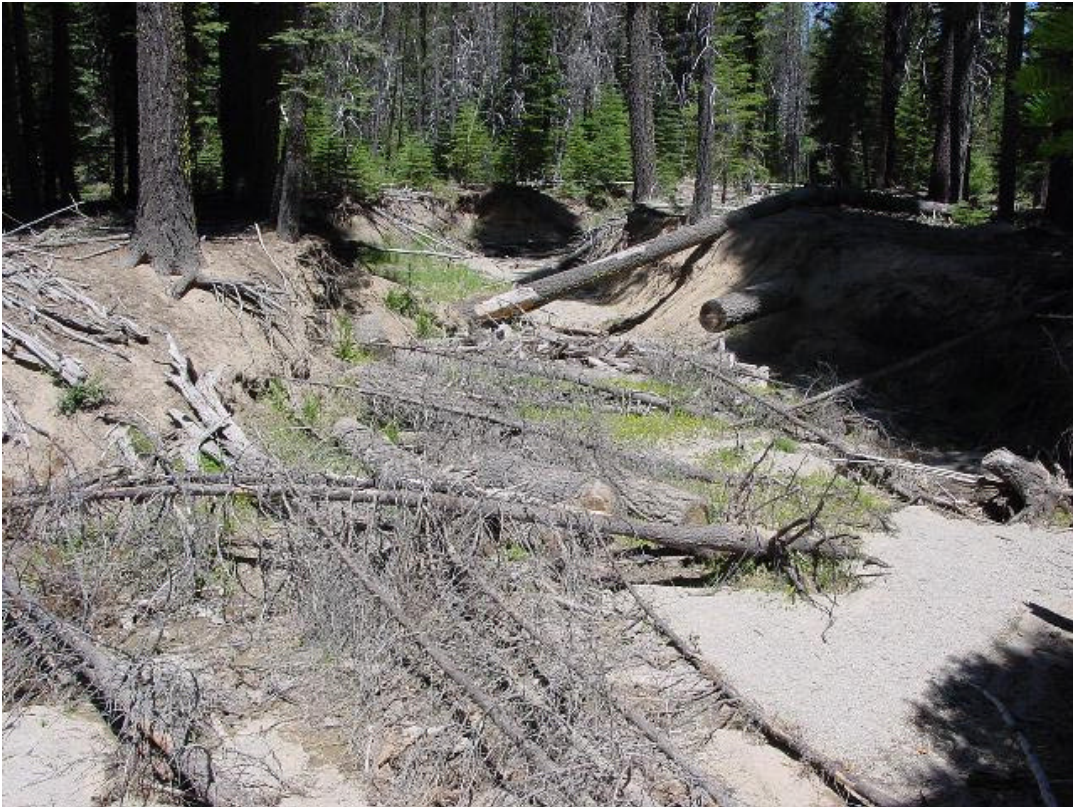
Photo 10.f

1422 Spur road—Collins log-debris dam

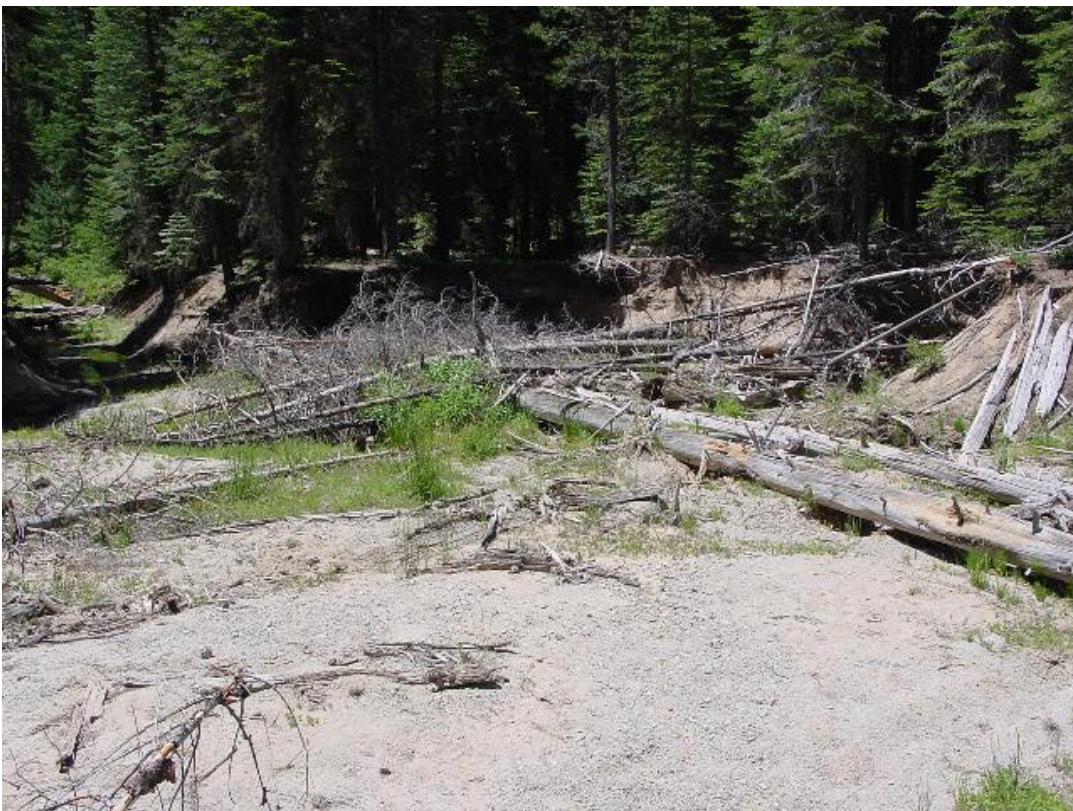
Photo 10.g

1422 Spur road—Natural log-debris dam

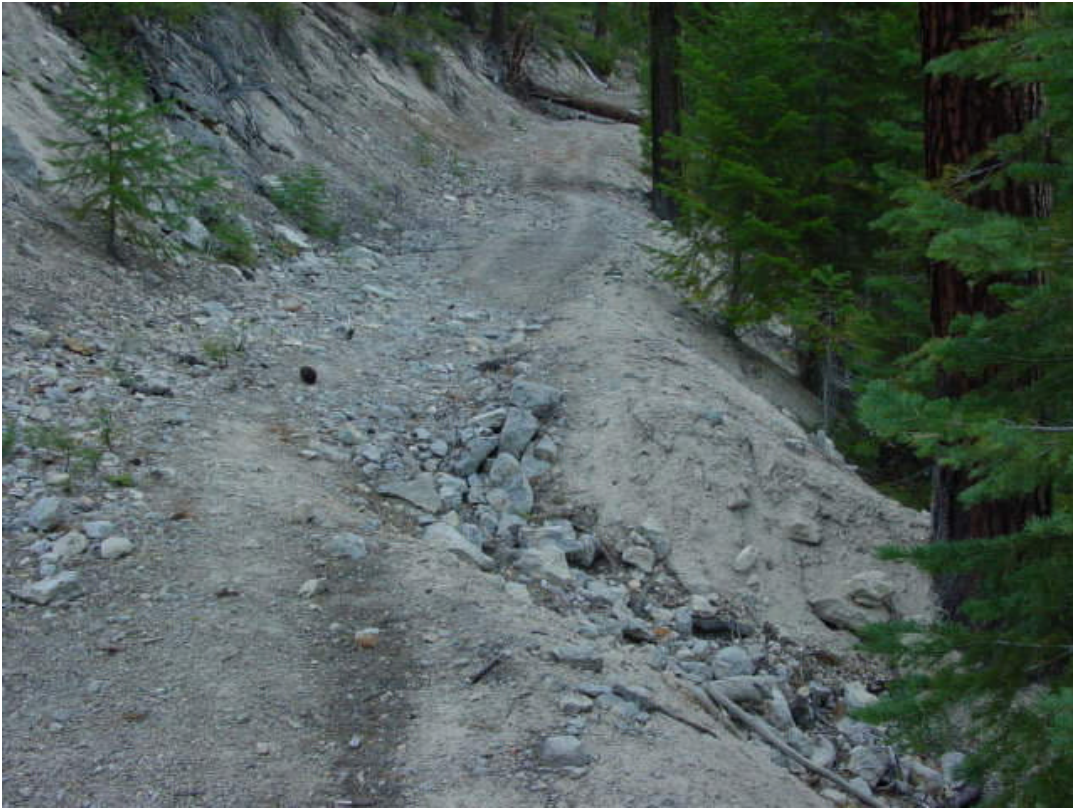
Photo 11.a

Site 11: 1420 Road looking down the road

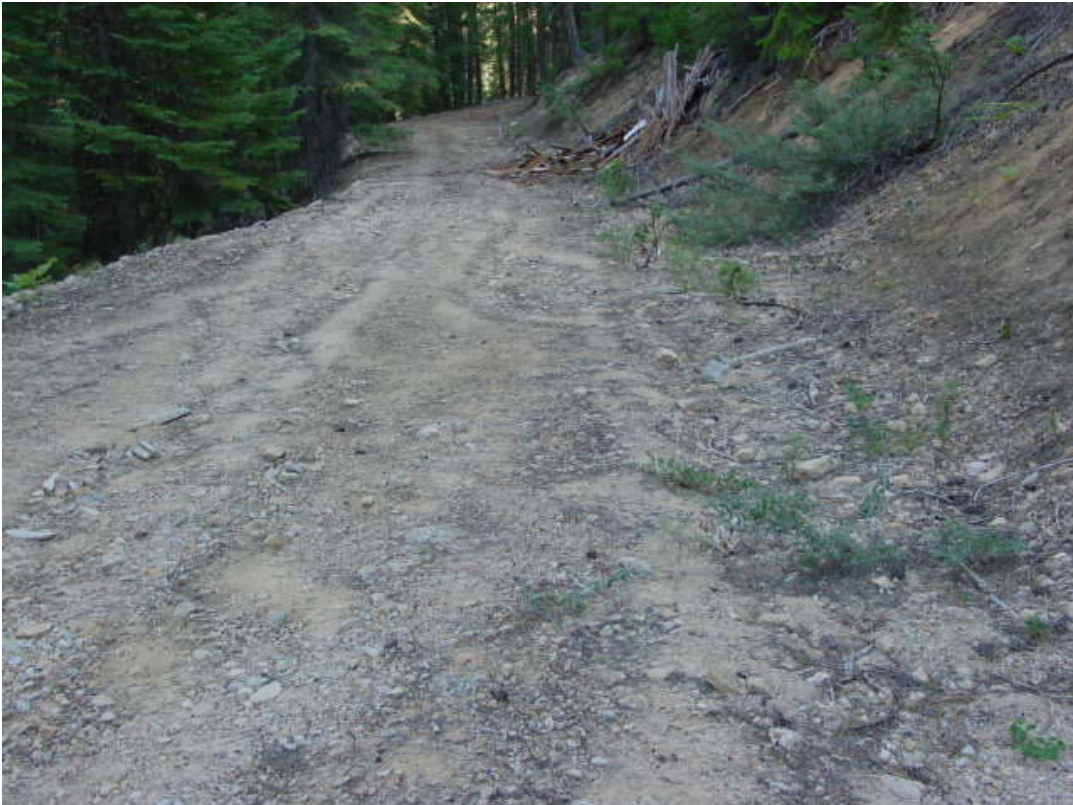
Photo 11.b

Site 11: 1420 Road looking down the road

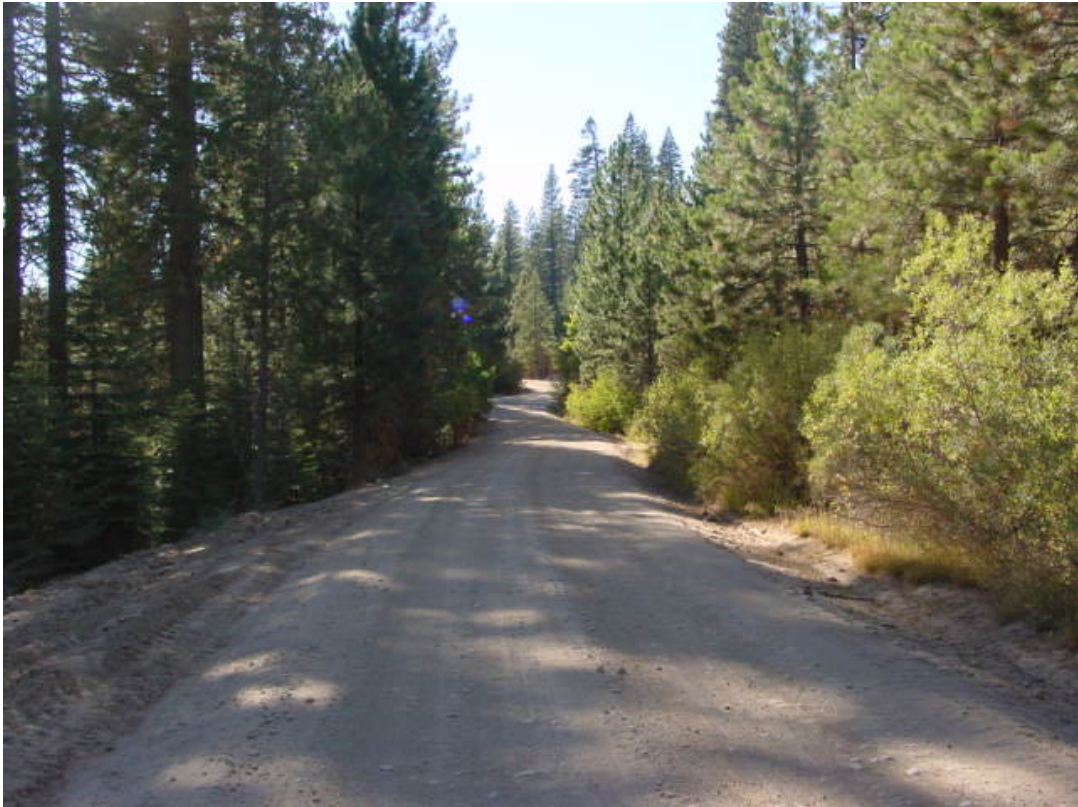
Photo 12.a

Main Road I east of Alder Creek.

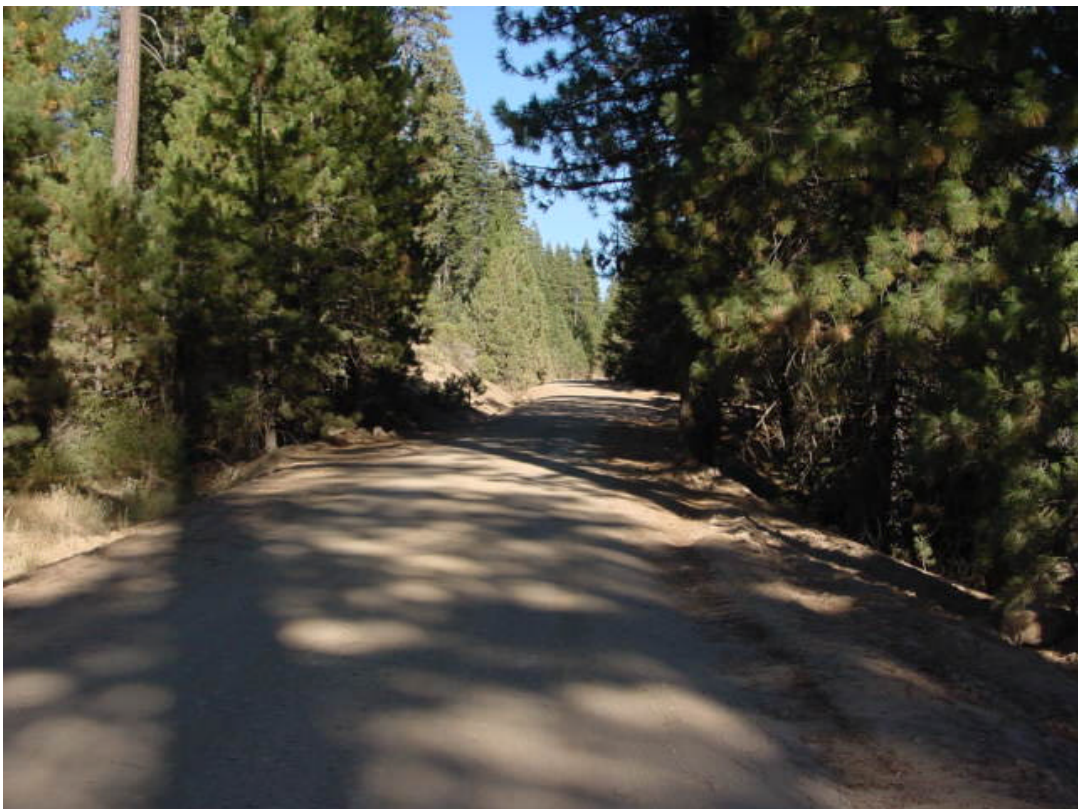
Photo 12.b

Main Road near its junction with Highway 32.

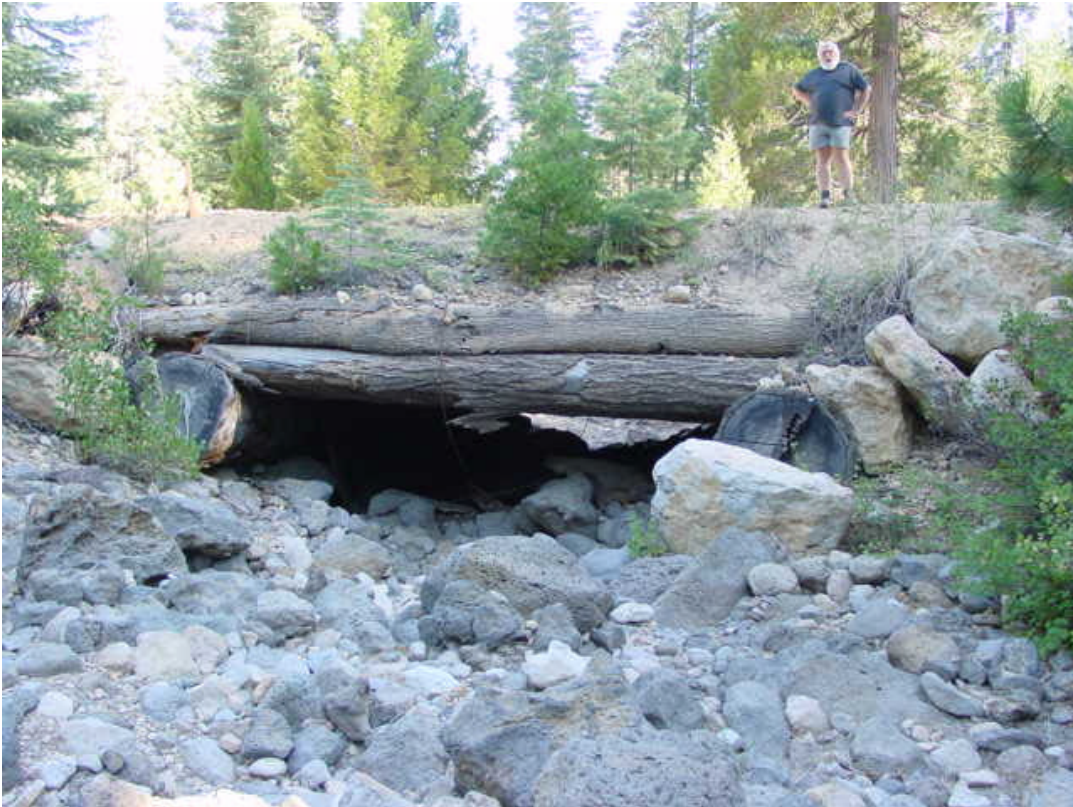
Photo 13.a

Site 13: View of Swamp Creek Bridge from upstream

Goals: Replace the decayed bridge with a more permanent structure that prevents bank erosion after collapse during high flow conditions. This work requires no equipment within the stream channel, beyond an excavator's bucket.

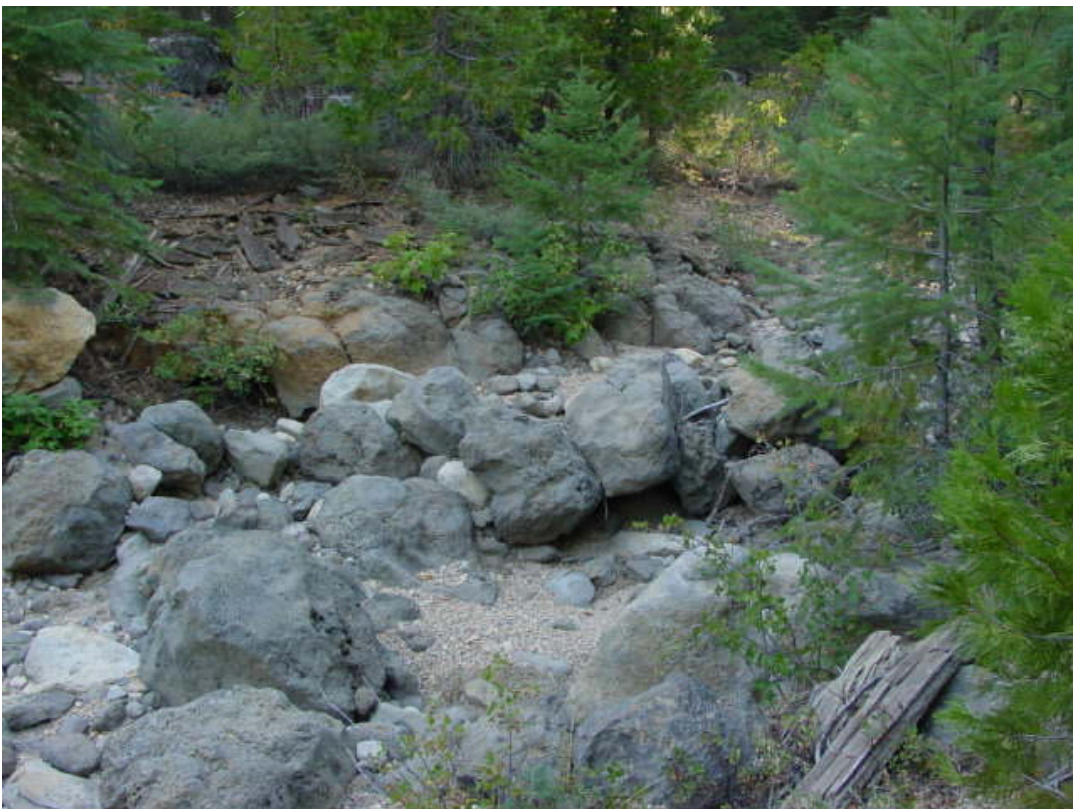
Photo 13.b

View of stream channel just below Swamp Creek Bridge

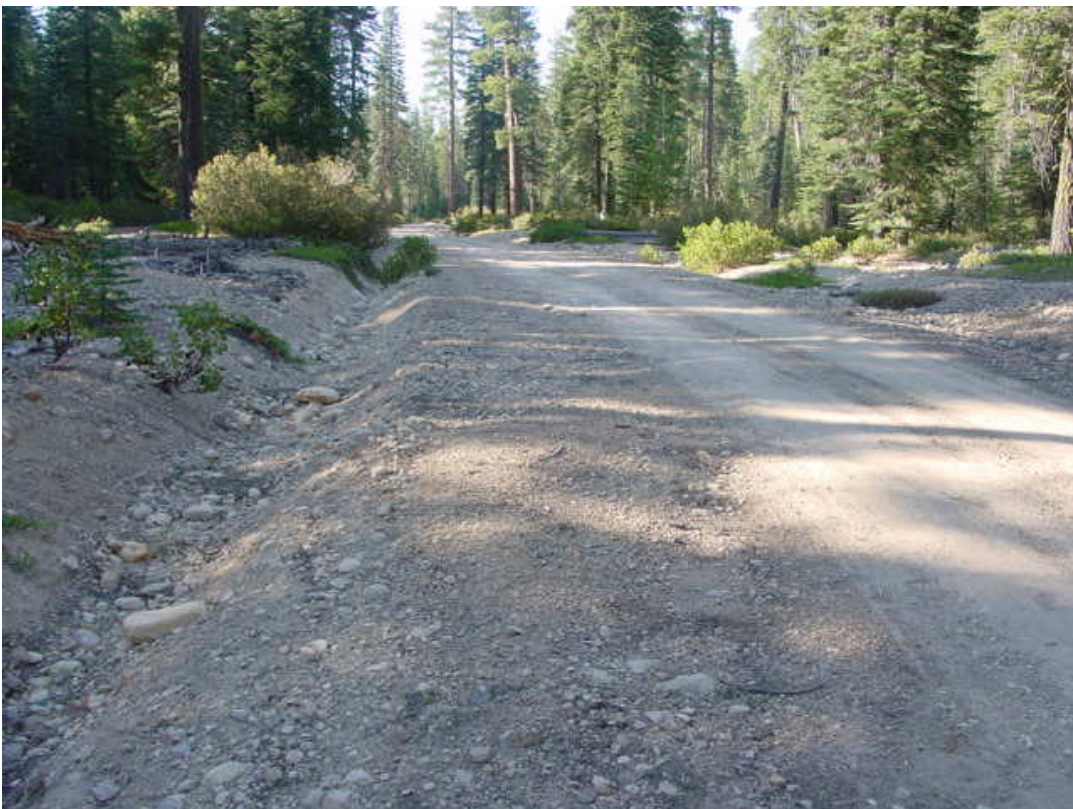
Photo 14.b

Site 14: 1700 Road

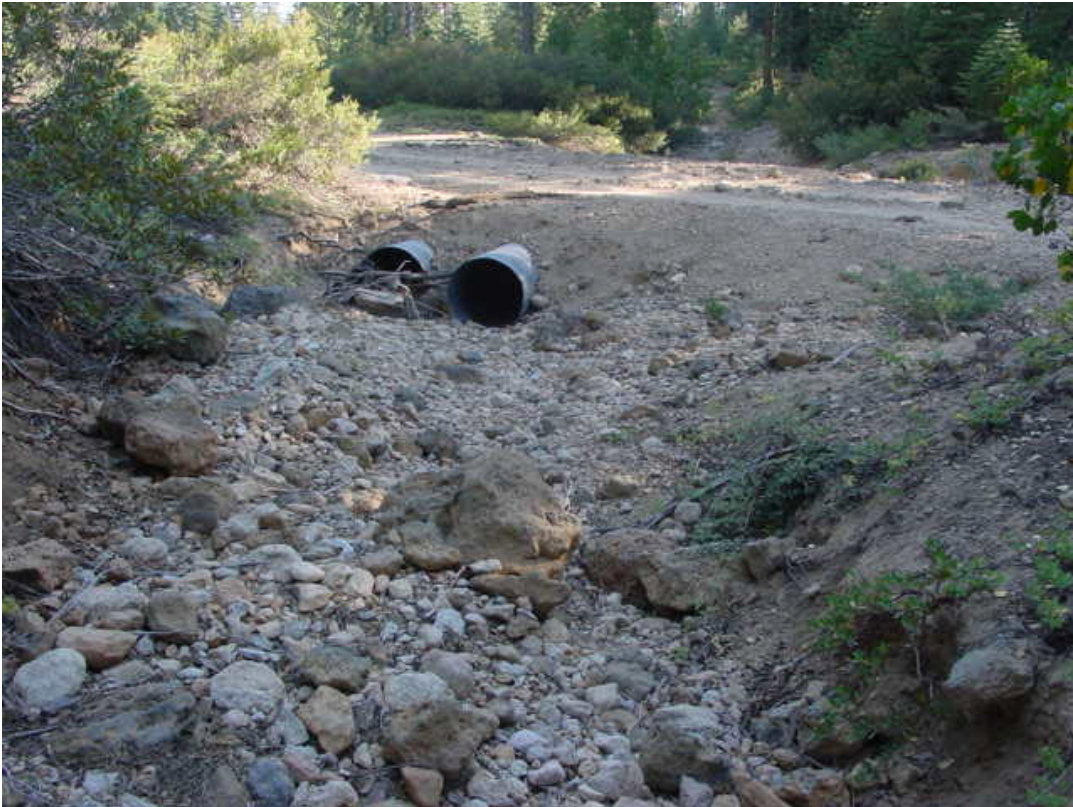
Photo 14.c

Site 14: 1700 Road cross drain

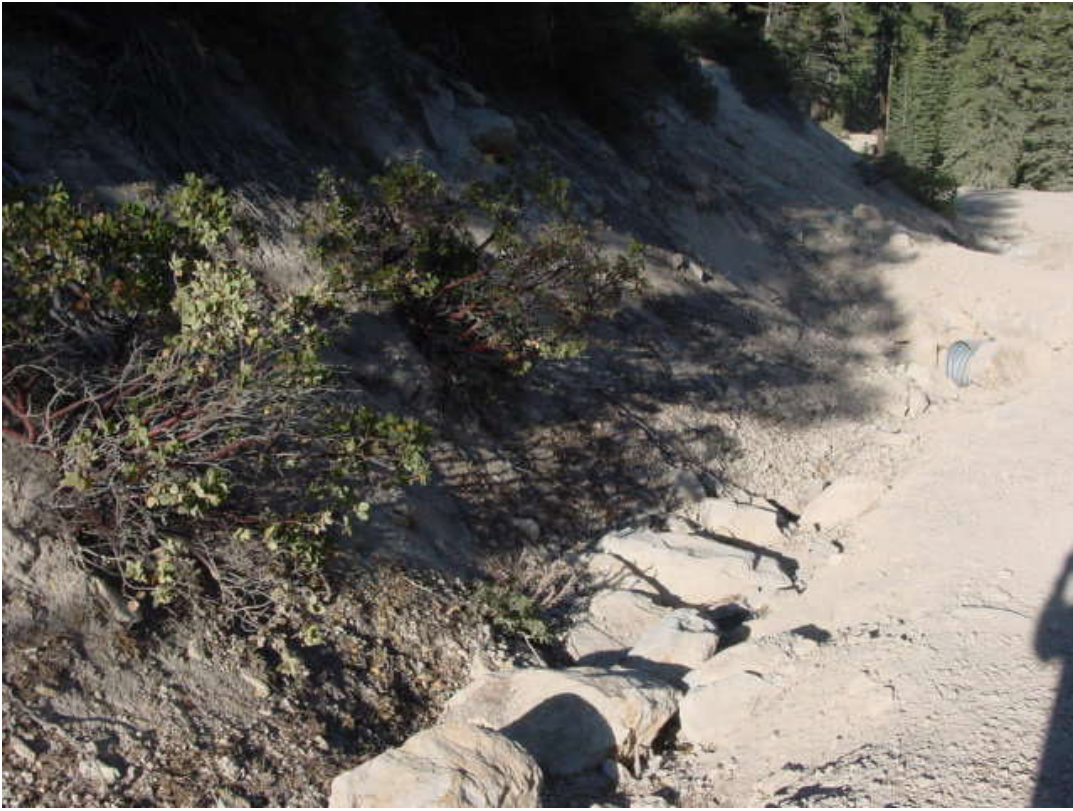
Photo 15.a

Specifics: This stretch of road was badly eroded after high winter flows in 1996. Repairs were made summer of 1997. Upon inspection, the ditch shows little soil movement and water flows in the ditch are very minor. This can be attributed partly to the cross drain culverts installed in 1997 and partly to the absence of heavy flows since then. Rocking the road surface, from the junction of the 1820 to the junction of the 1821, appears more beneficial in reducing sediment transport than working on the ditch or cross drain culverts.

Site 15: 1820 Road cross drain and inside ditch

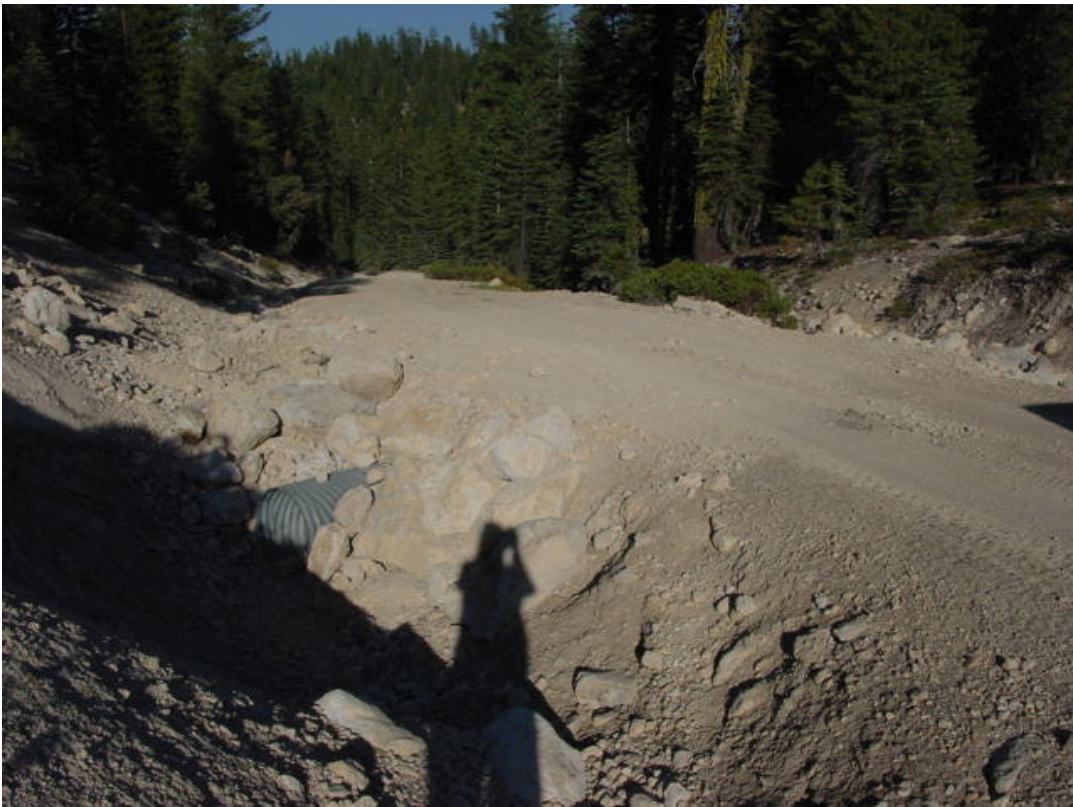
Photo 15.b

Site 15: 1820 Road cross drain, inside ditch and road surface

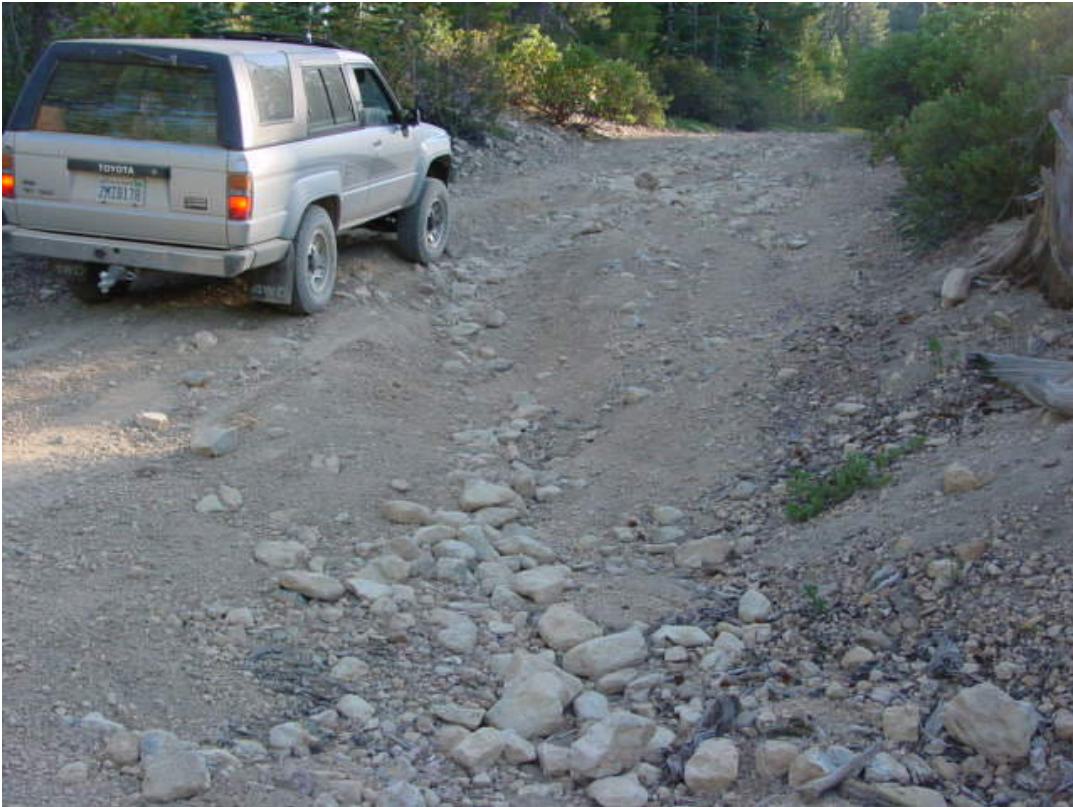
Photo 16.a

Site 16: 1821 Road

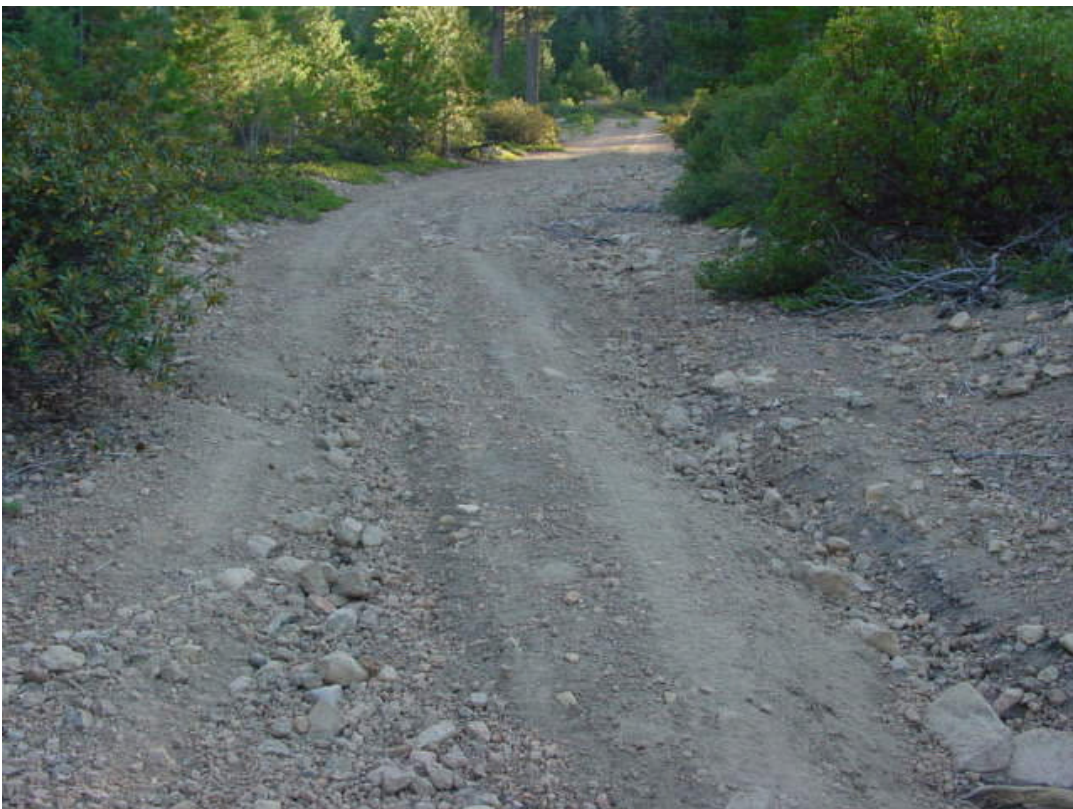
Photo 16.b

Site 16: 1821 Road

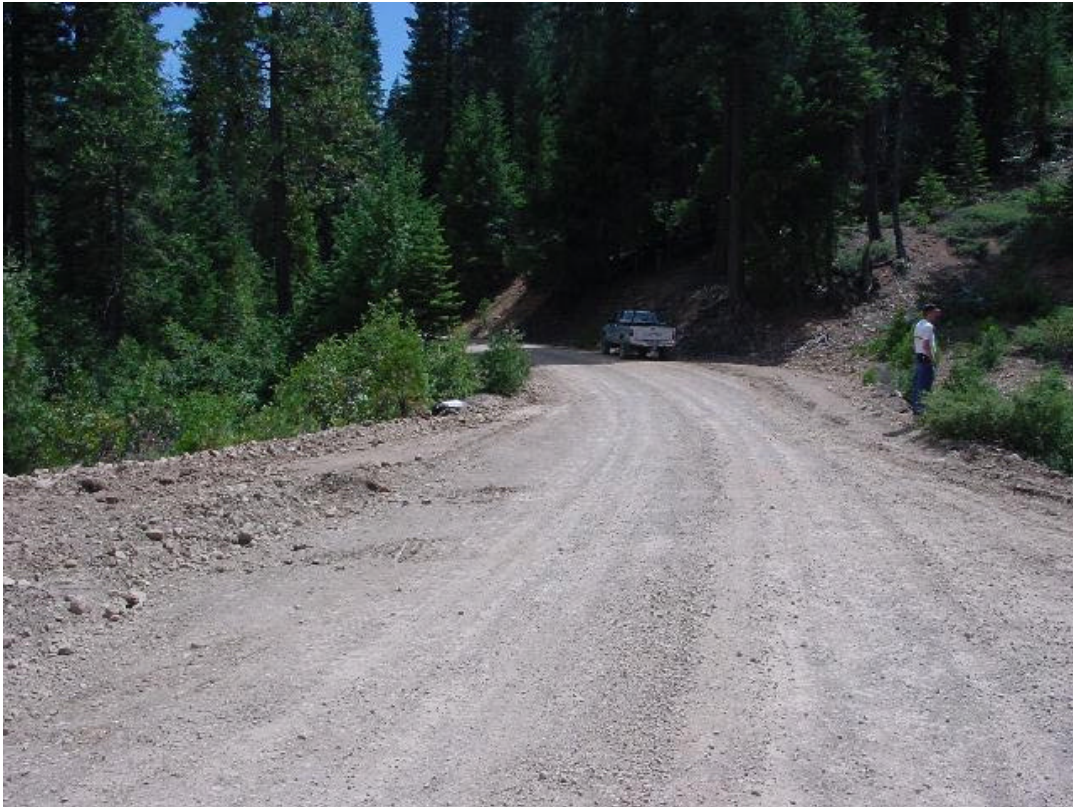
Photo 17.a

Main Road I—Swamp Creek bridge—road across bridge.

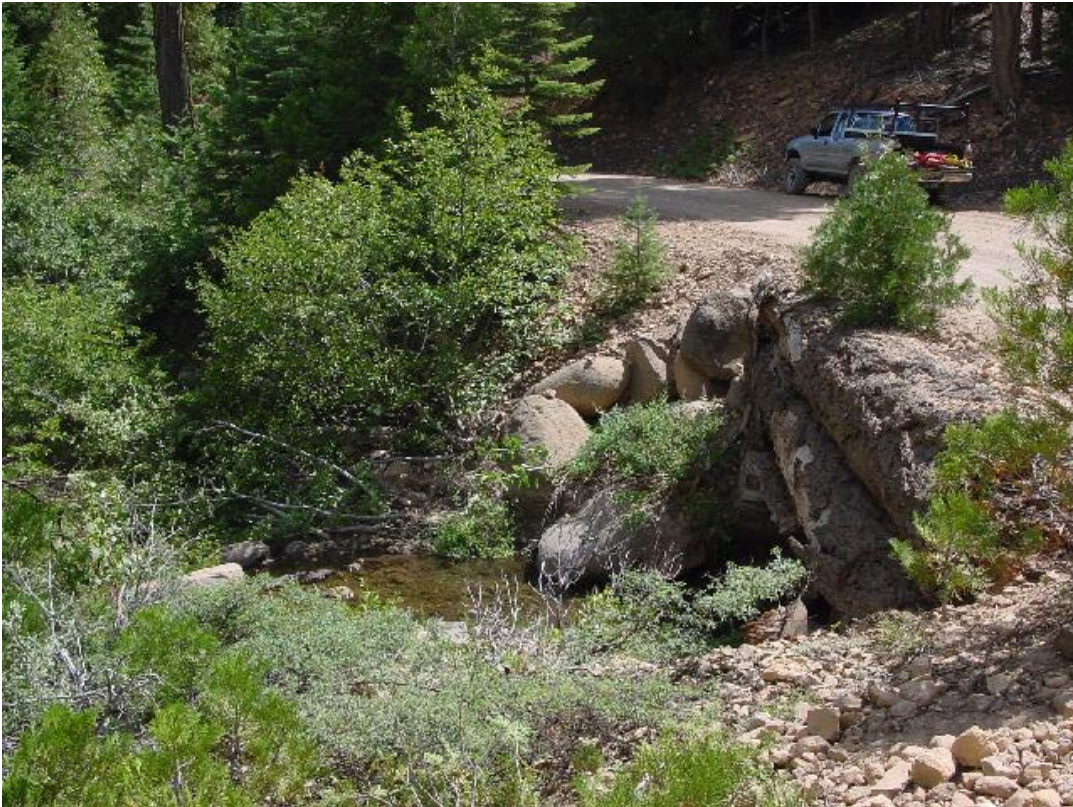
Photo 17.c

Main Road I—Swamp Creek bridge— looking west at proposed new location

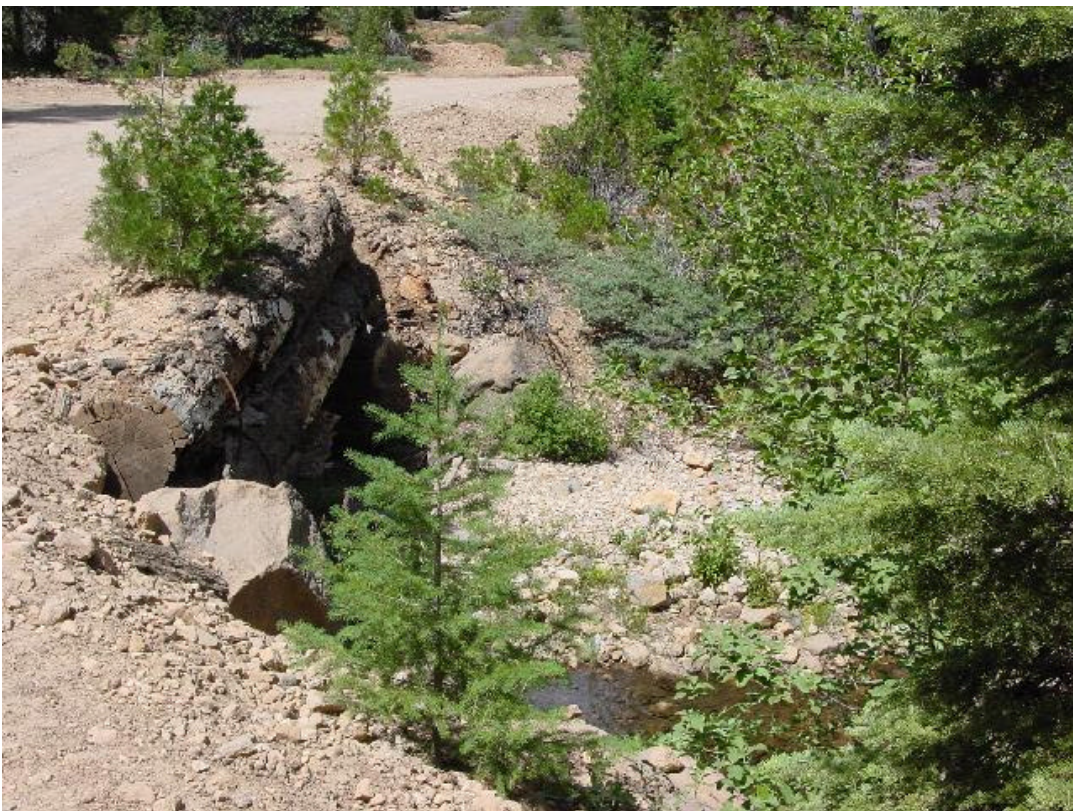
Photo 17.d

Main Road I—Swamp Creek bridge— looking east at proposed new location
